Manhole Inspection Summary

Manhole # S150__045MH

Location Address: **2701 east lynne av**

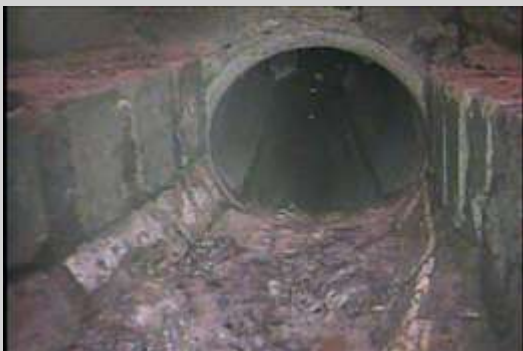
3 O'Clock Inflow

Pipe Height: **8.4** (in.) Rod and Bar (Angled)
Pipe Material: **Clay** ☐ Pipe Lined
Invert Depth: **9.23** (ft.) Flow Characteristics: **Slow**
Deposits: ☒ **None** ☐ Mud ☐ Sludge ☐ Debris ☐ Grease
Silt Depth: **0** (in.) Deposits Extent:
Infiltration: **None** Pipe Seal Cond: **Sound**
